# REPAIR OF EMBANKMENT FAILURE ON TERRE ROUGE- VERDUN ROAD

# Occurrence of cracks on Terre Rouge Verdun Link Road (TRVLR) and embankment collapse over a stretch of 260 meters in January 2015

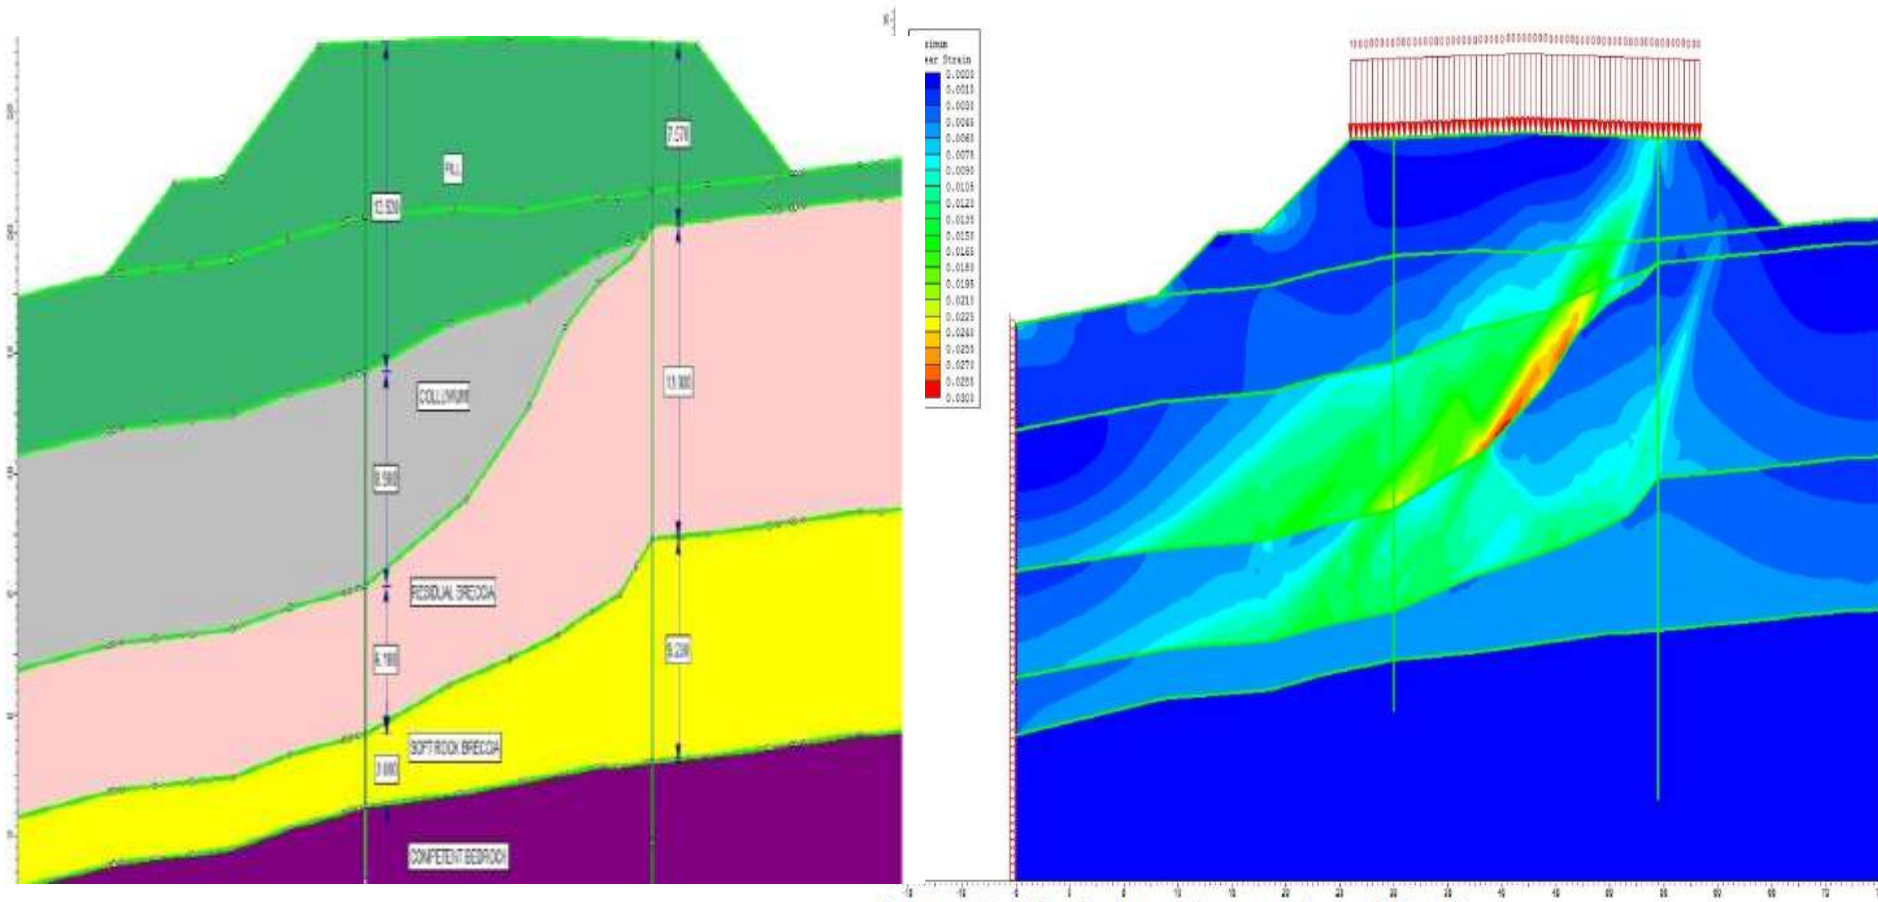
Figure 8-8: SLS - Maximum shear strains at CH 8 240

# Finite element analysis carried out to determine causes of embankment failure due to a layer of soft colluvium and residual breccia

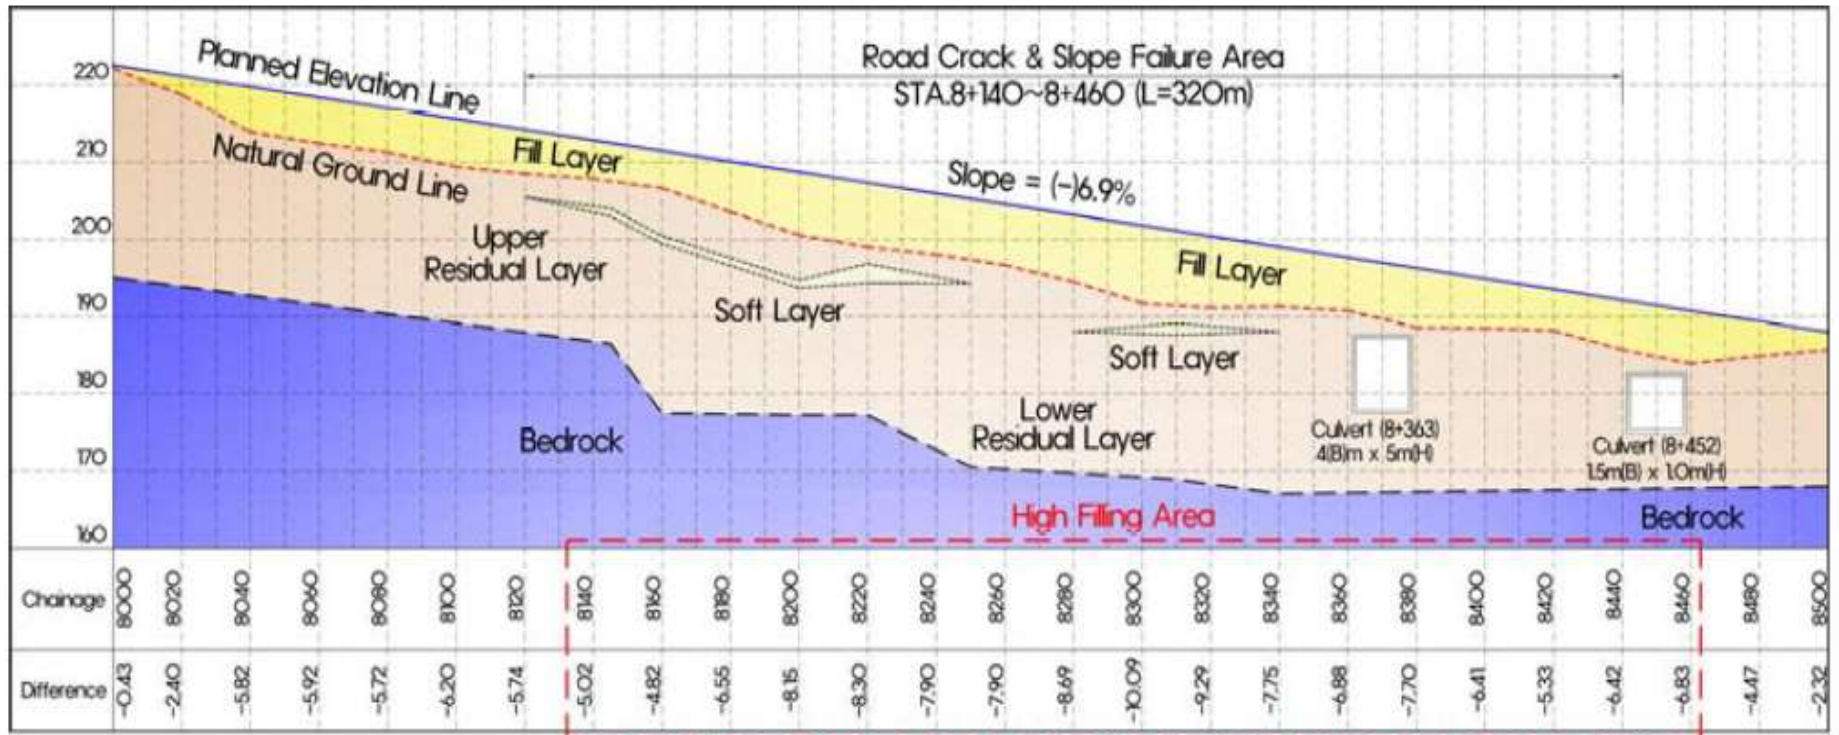
Fig-18 Longitudinal Section

# Embankment Failure Area

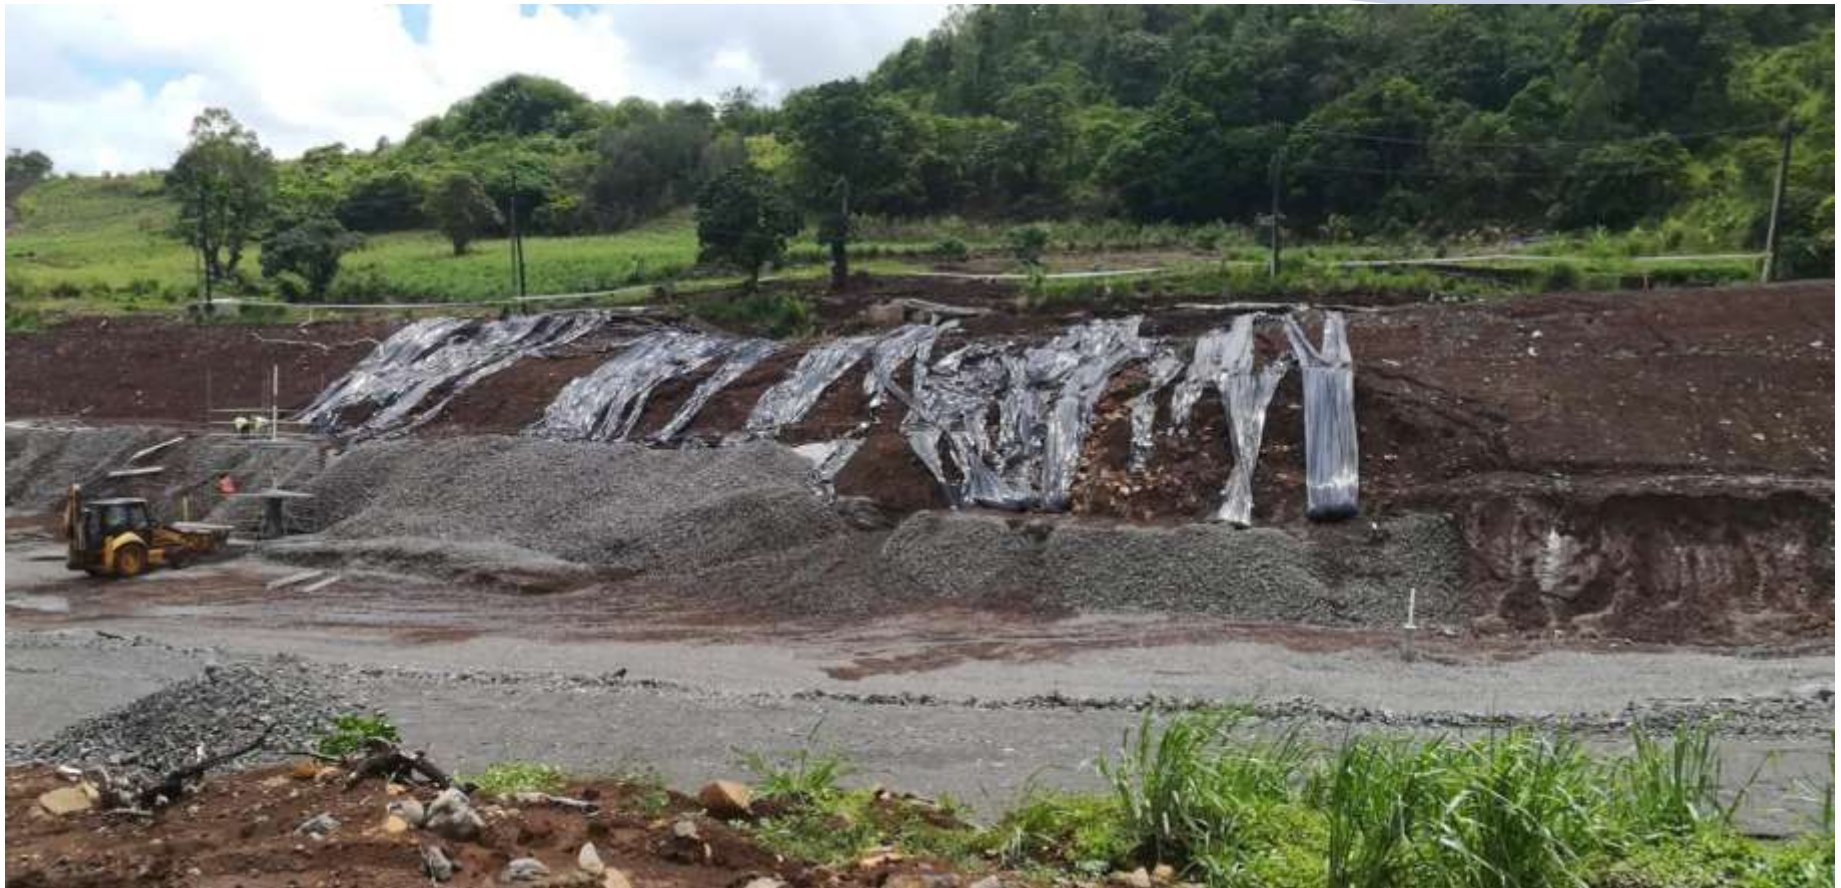
# Landslide During Excavation
